## Understanding Polymer Material Properties for PV Module Reliability

Michael Owen-Bellini – NREL Soňa Uličná - SLAC

DuraMAT Webinar May 2021

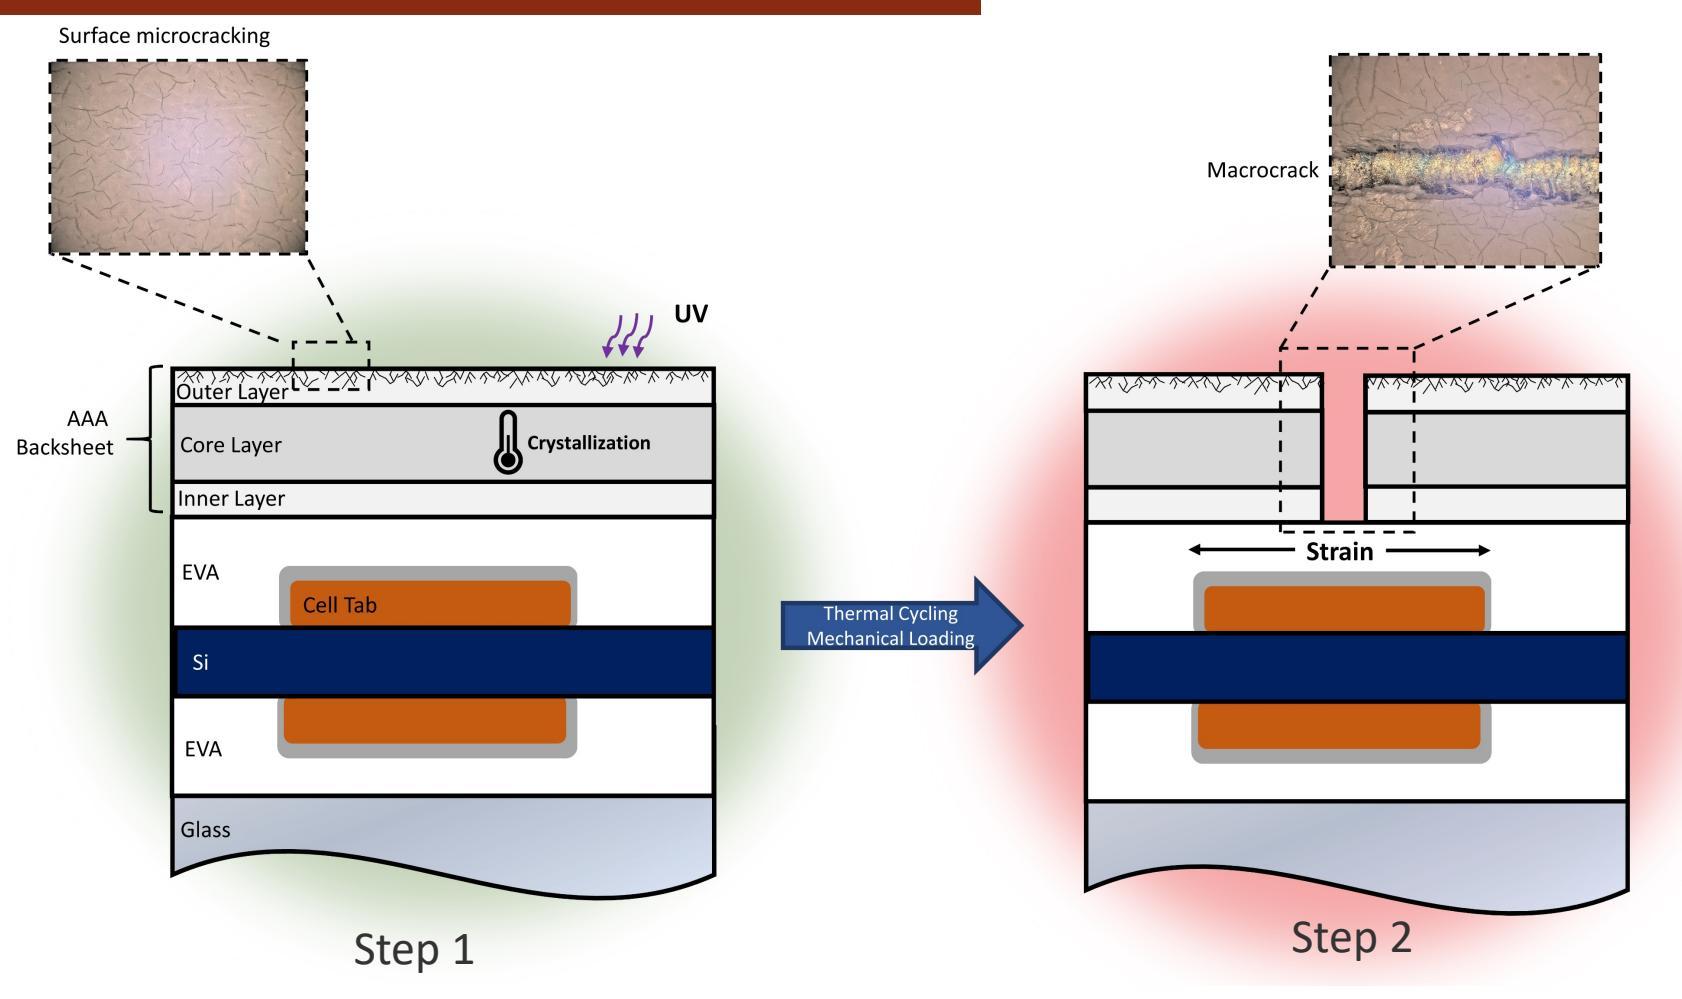
Failure is a 2-step process:

Step 1: Microcracking / fracturing of the outer layer due to photooxidation and crystallization of the polypropylene

Step 2: Macrocracking, or through cracking, due to thermomechanical/mechanical strain

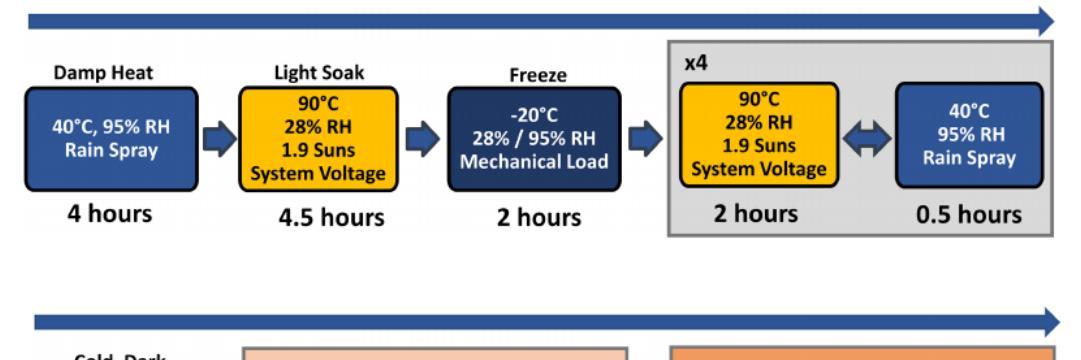
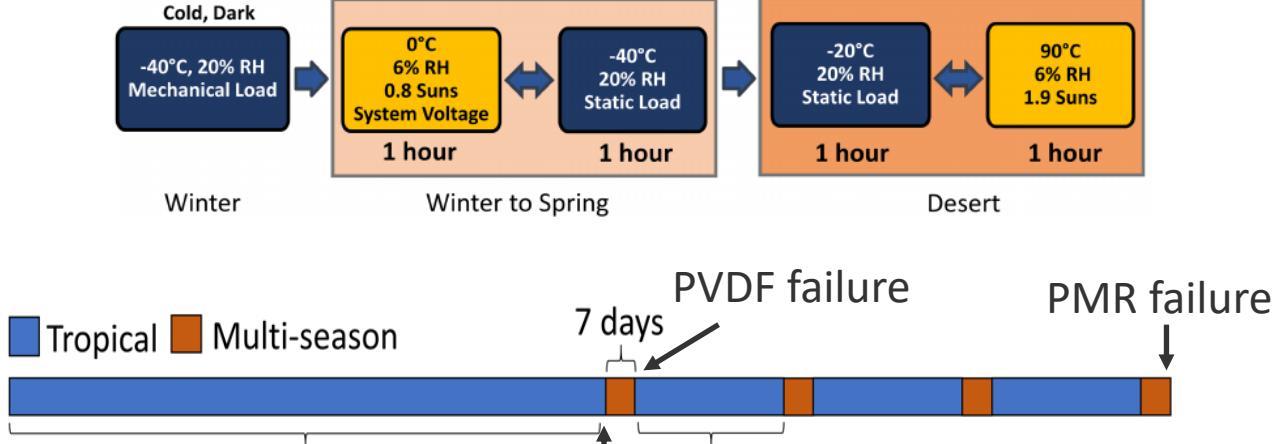
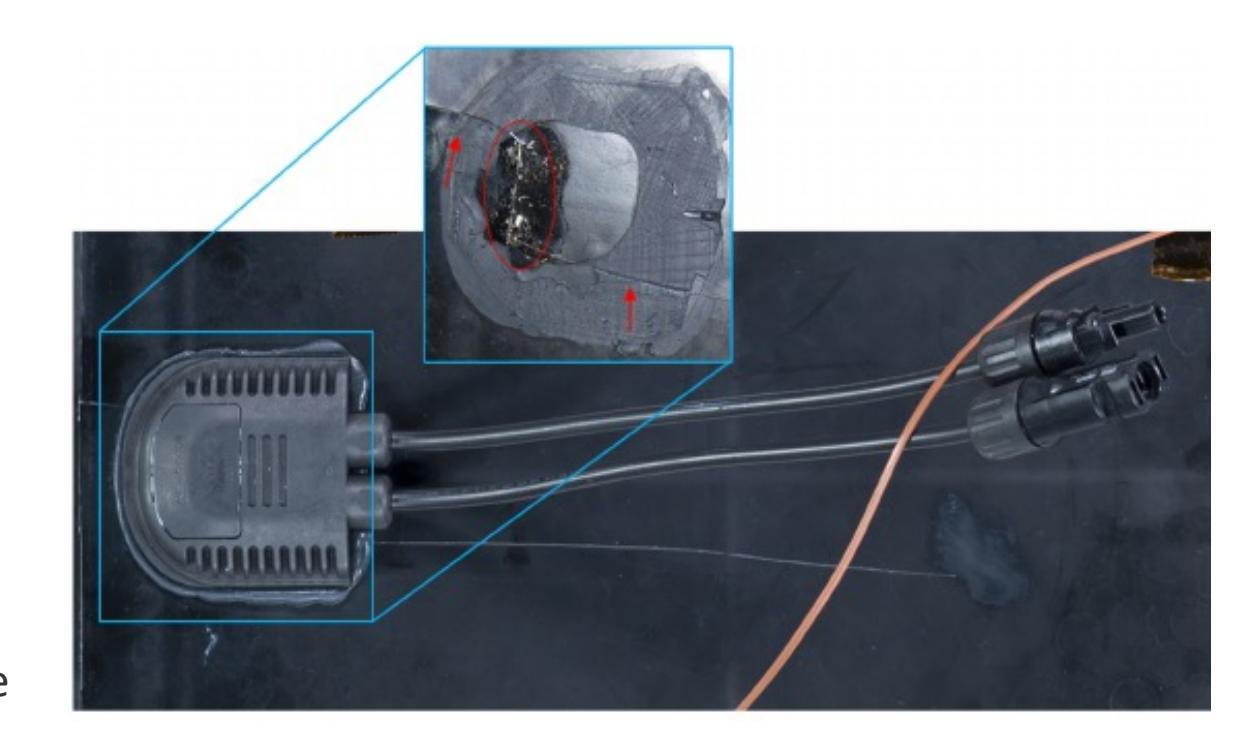
AAA failure

135 days

35 days

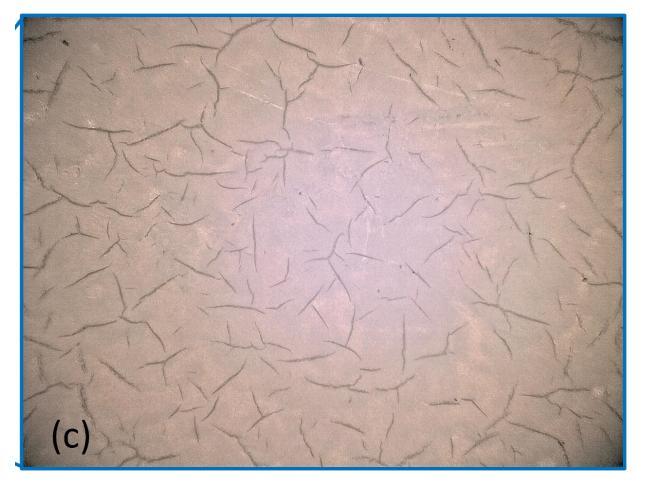
Surface microcracking of AAA attributed to UV photo-oxidation

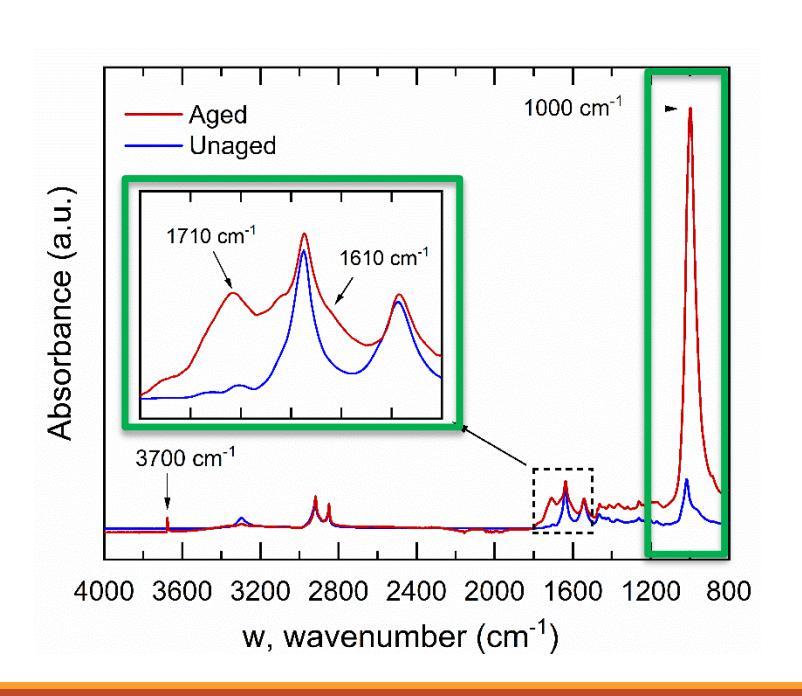
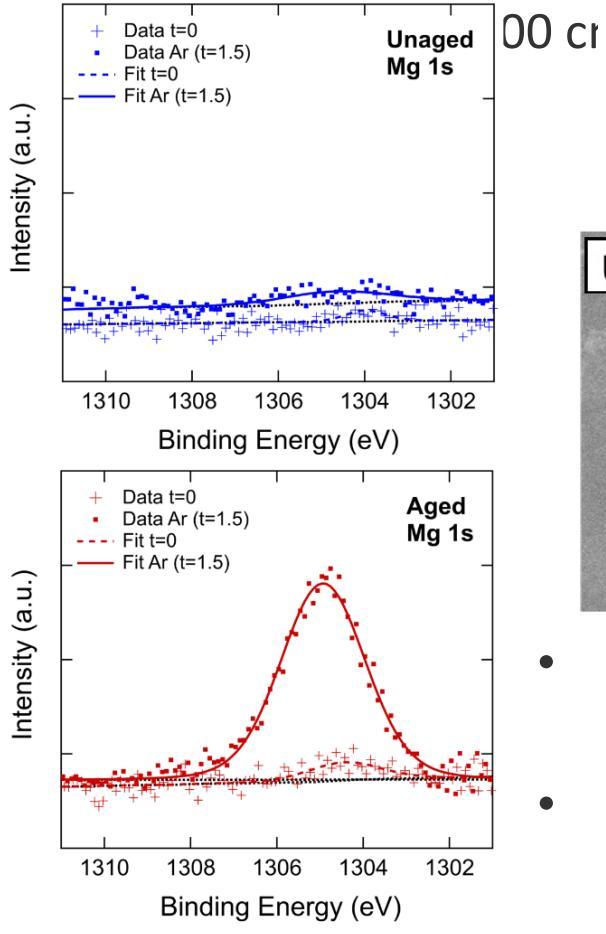
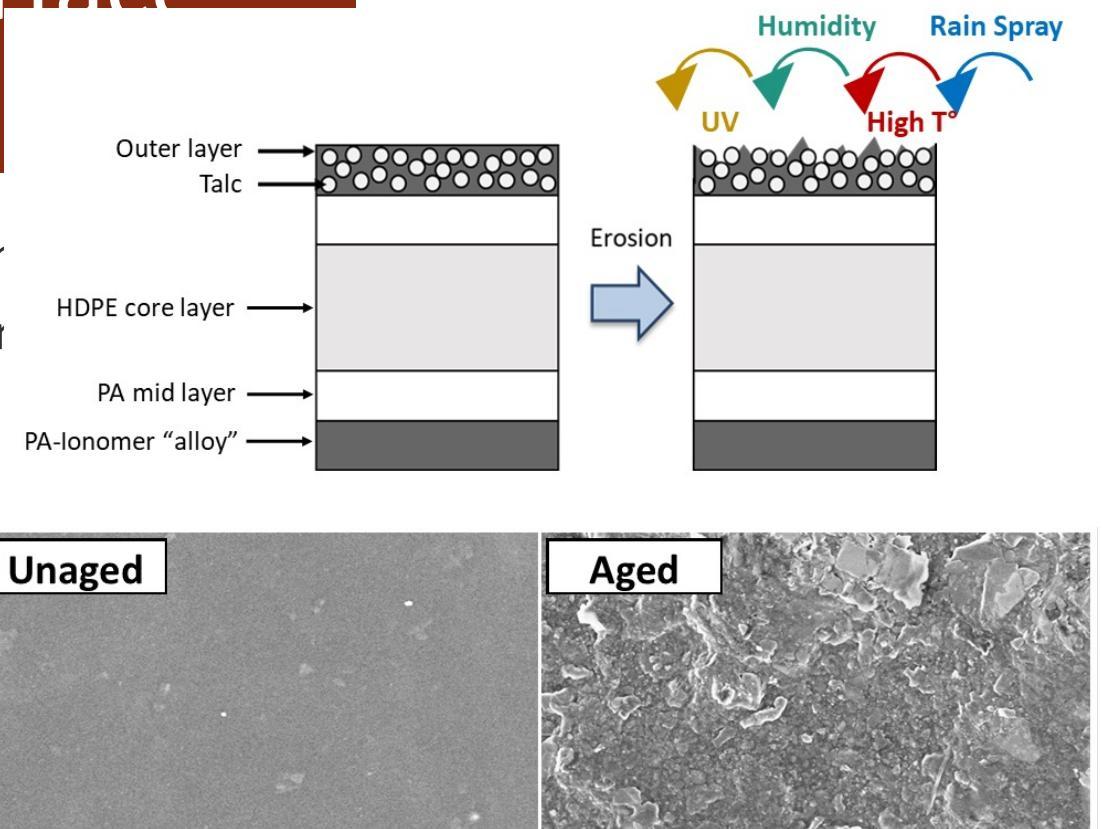
- Increase in peaks at 1710 (FTIR): photo-oxidation of polyar
- Significant increase in peak at from talc mineral filler

- Higher amount of Mg detected on the surface (XPS): talc = Mg<sub>3</sub>Si<sub>4</sub>O<sub>10</sub>(OH)<sub>2</sub>
- Increase in surface roughness after aging (SEM): hypothesis of surface erosion

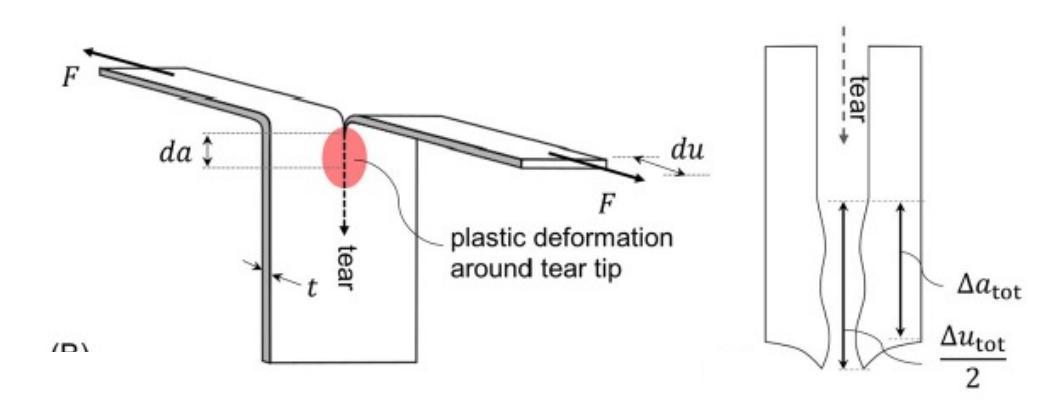
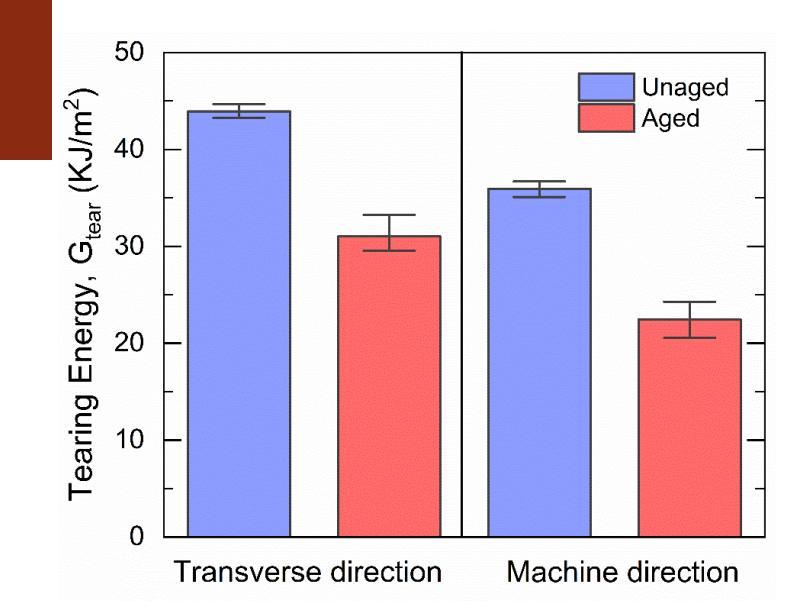
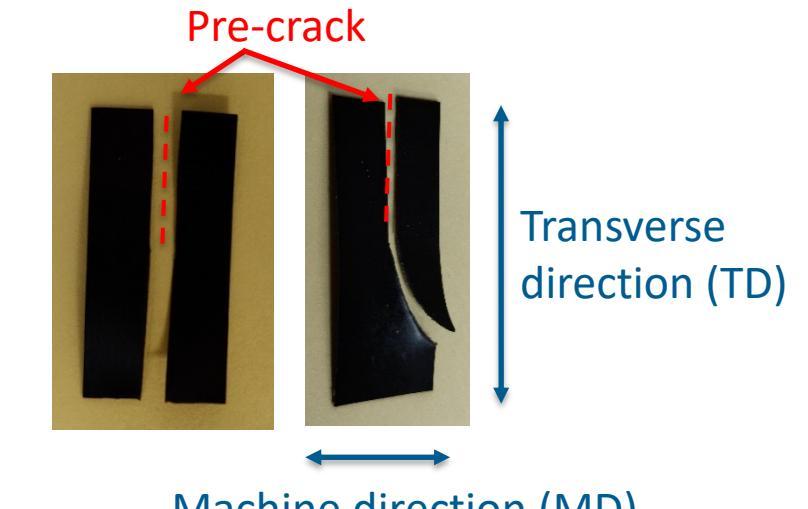
- Trouser tear test: correlate the changes in material properties with backsheet mechanical properties
- Lower tear energies upon aging confirm backsheet embrittlement caused by increased crystallization of HDPE core layer
- When tearing aged backsheet in TD, tear propagated in weaker MD: same as the crack leading to failure in C-AST
