“BACKFLIP: A Comparison of Emerging Non-Fluoropolymer-Based, Co-Extruded PV Backsheets to Industry-Benchmark Technologies”

*Comparison of market-benchmark **BACK**sheet technologies to novel non-**FL**uoro-based co-extruded materials and their correlation and **ImPact** on PV module degradation rates (**BACKFLIP**)*

Naila M. Al Hasan, Rachael L. Arnold, Bruce King, David C. Miller*, Jimmy M. Newkirk, Emily Rago, Laura T. Schelhas, Archana Sinha, Kent Terwilliger, Michael Thuis, and Soňa Uličná

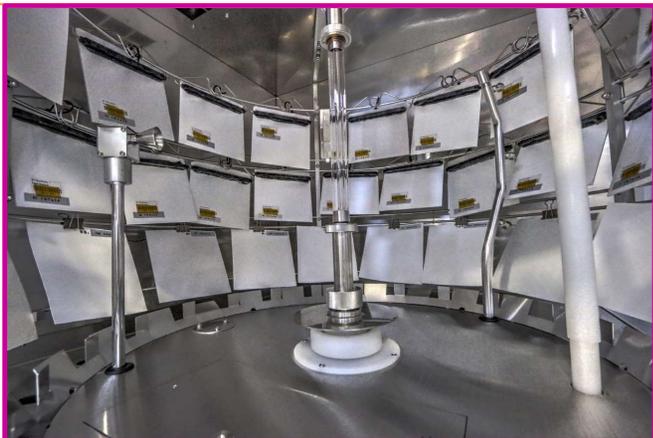
Coupon and MiMo specimens in Xe UV chamber (inside the carousel)

- **UV weathering** performed in high spectral fidelity Atlas “Weather-ometer” Xe lamp (ASTM D7869) chambers.
17 cm MiMo size avoids shading between carousel rows.
⇒ ¼ cell MiMo’s used at NREL.
Removable cables, with j-box end caps.
- **Hygrometric aging** performed in separate dark chambers.

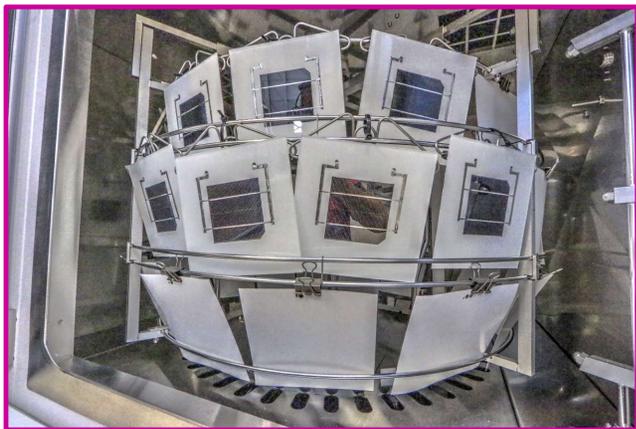
Coupon and MiMo specimens in Xe UV chamber (outside the carousel)

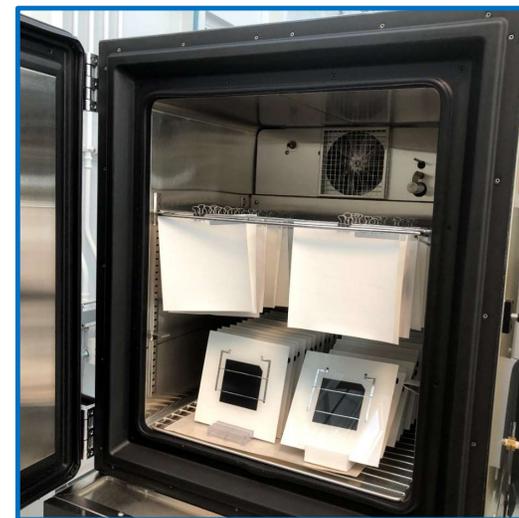
Coupon and MiMo specimens in hygrometric chamber

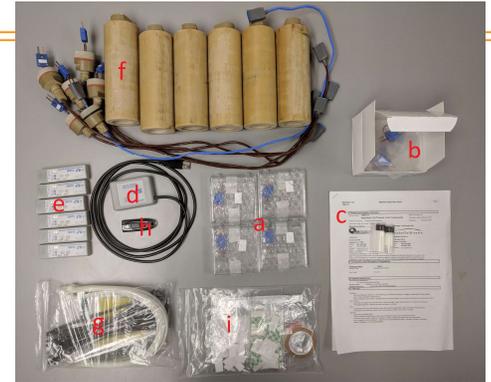
Kit from previous study, including wireless transmitters and their housing used here.
