An Update from the cell cracking working group on DuraMAT's effort on Detecting, Assessing, and Mitigating Power Loss of Cracked Cells

Martin Springer (NREL), Jennifer Braid (SANDIA), Xin Chen (LBL), Tim Silverman (NREL), Sang M Han (OSAZDA), and Oliver Zhao (Stanford University)

DuraMAT webinar 2021-07-12

Publication Number: NREL/PR-5K00-80495

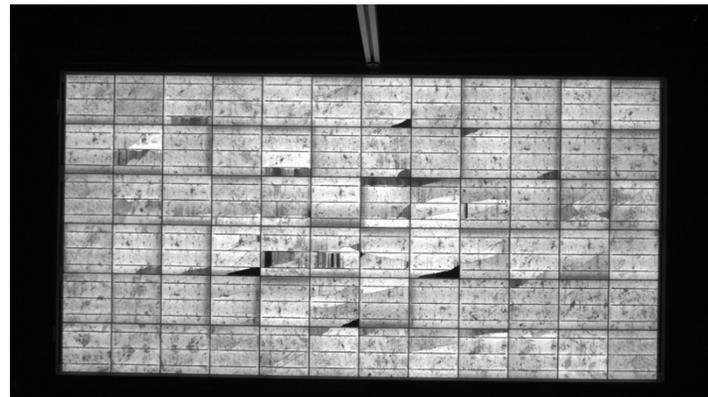
Electroluminescence image of solar module in lab

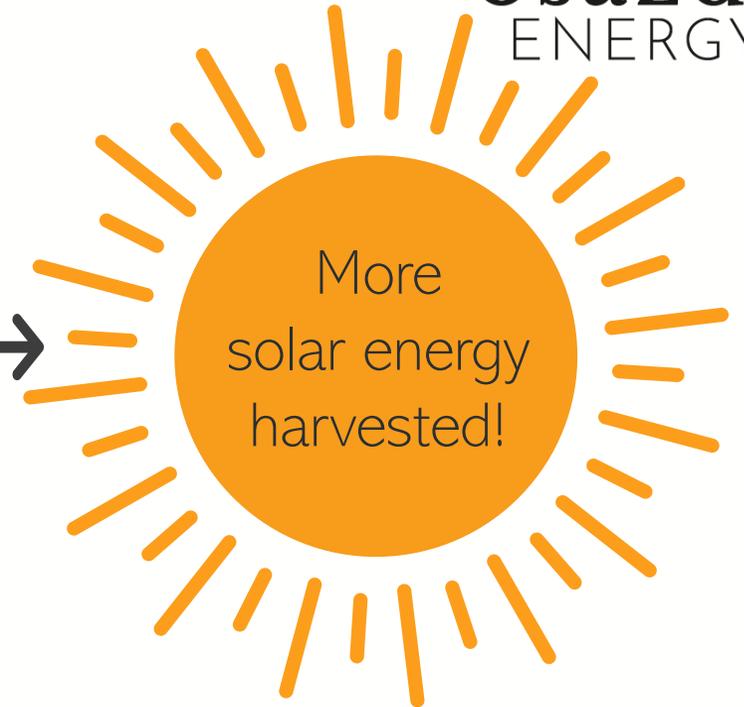
MetZilla additive +
silver paste

makes fragile gridlines
tough & elastic

minimizing losses from
cracking
