Materials forensics for understanding PV module material durability

Laura T. Schelhas

SLAC National Accelerator Laboratory

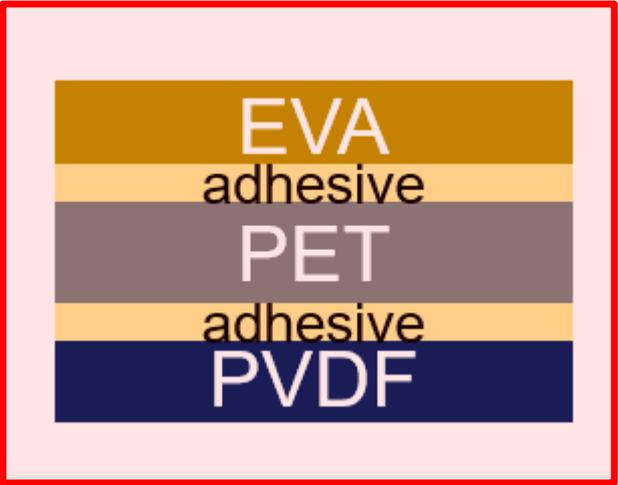
Damp heat-induced mechanical changes

85 %RH /85° C

Damp heat (DH) =
85% humidity + 85° C

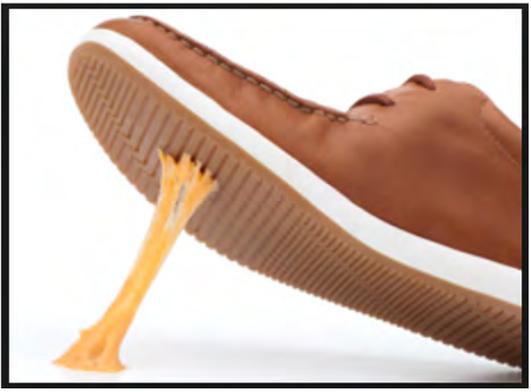
EVA

after 2000 hours

New phase may further enable EVA to undergo plastic deformation (cold-drawing)

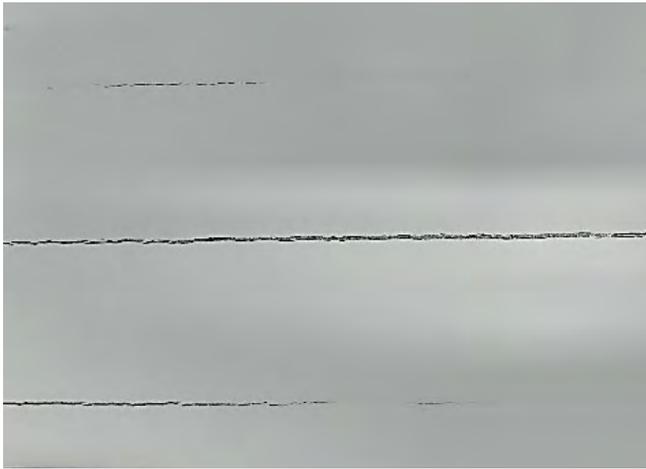
CAST accelerated-aging of PA

PA: poly-amide-based backsheet

CAST: Combined accelerated
stress testing

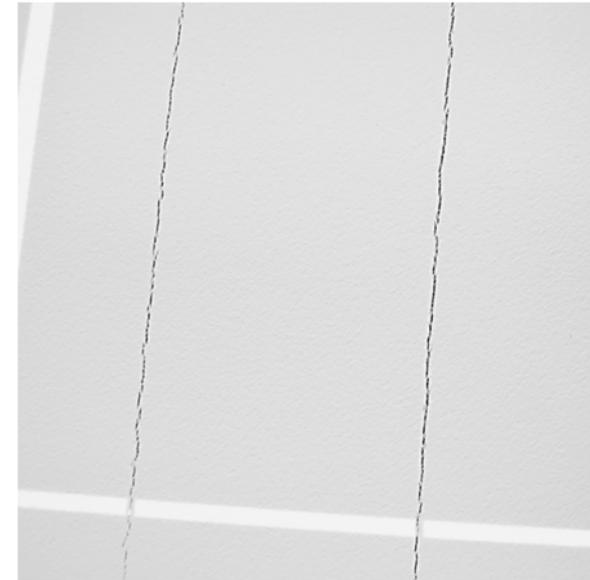
Field-deployed for 5 years
