# Project Updates and Progress at Sandia's Field Test Site

**Elizabeth Palmiotti, Bruce King**  
*Sandia National Laboratories*

# DuraMAT Fielded Projects at Sandia

# DuraMAT Module Library

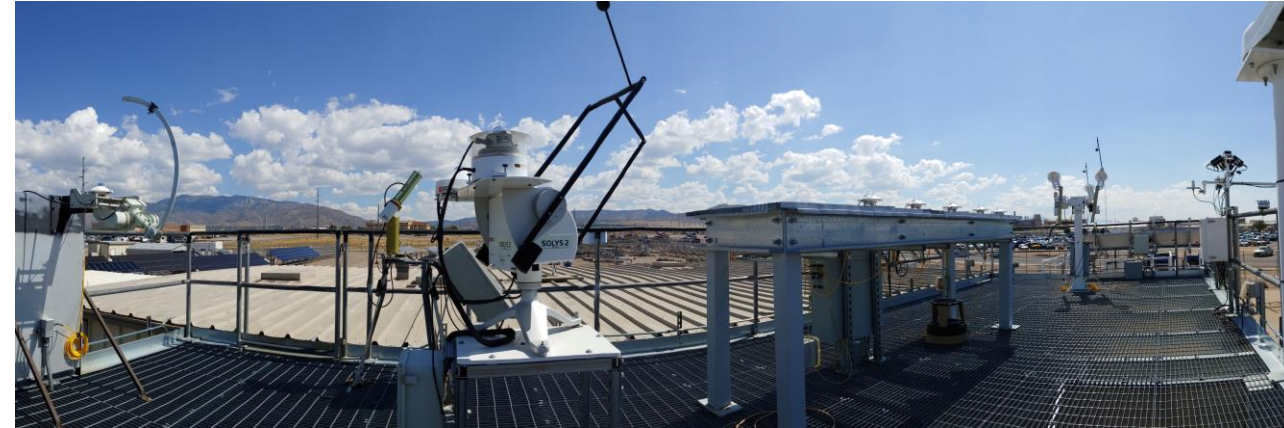
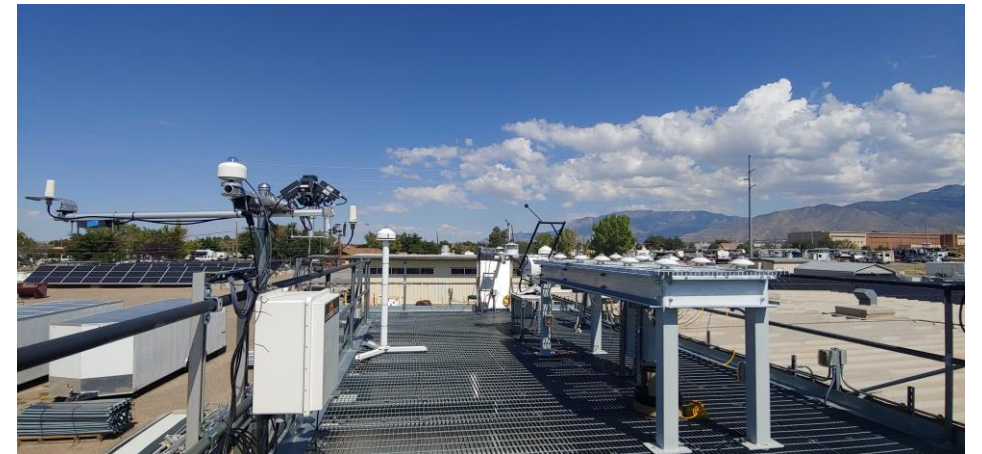
# Sandia Field Test Site

- Weather and solar irradiance summary
- Comprehensive Weather Platform
  - Primary and secondary trackers
    - DNI, GNI, diffuse, spectrum
  - Fixed orientation
    - GHI, Global Latitude, UV, spectrum
  - Non-irradiance
    - Ambient temperature, windspeed/direction (10m), barometric pressure, humidity, rainfall
- In-field Measurements
  - Plane-of-array pyranometer, reference cells
- Data Collection
  - 1s data rate
  - Written to database, GPS synchronized with other field measurements
- Other as needed
  - Rear-side irradiance for bifacial

*All on-site calibrations traceable to the World Radiometric Reference via NREL Pyrheliometer Comparison*
