Changes in Field Failure Degradation Modes Over Time

Duramat Workshop

**Dirk Jordan, Tim Silverman, Sarah Kurtz, John Wohlgemuth,
Kaityln VanSant**

5/23/2017

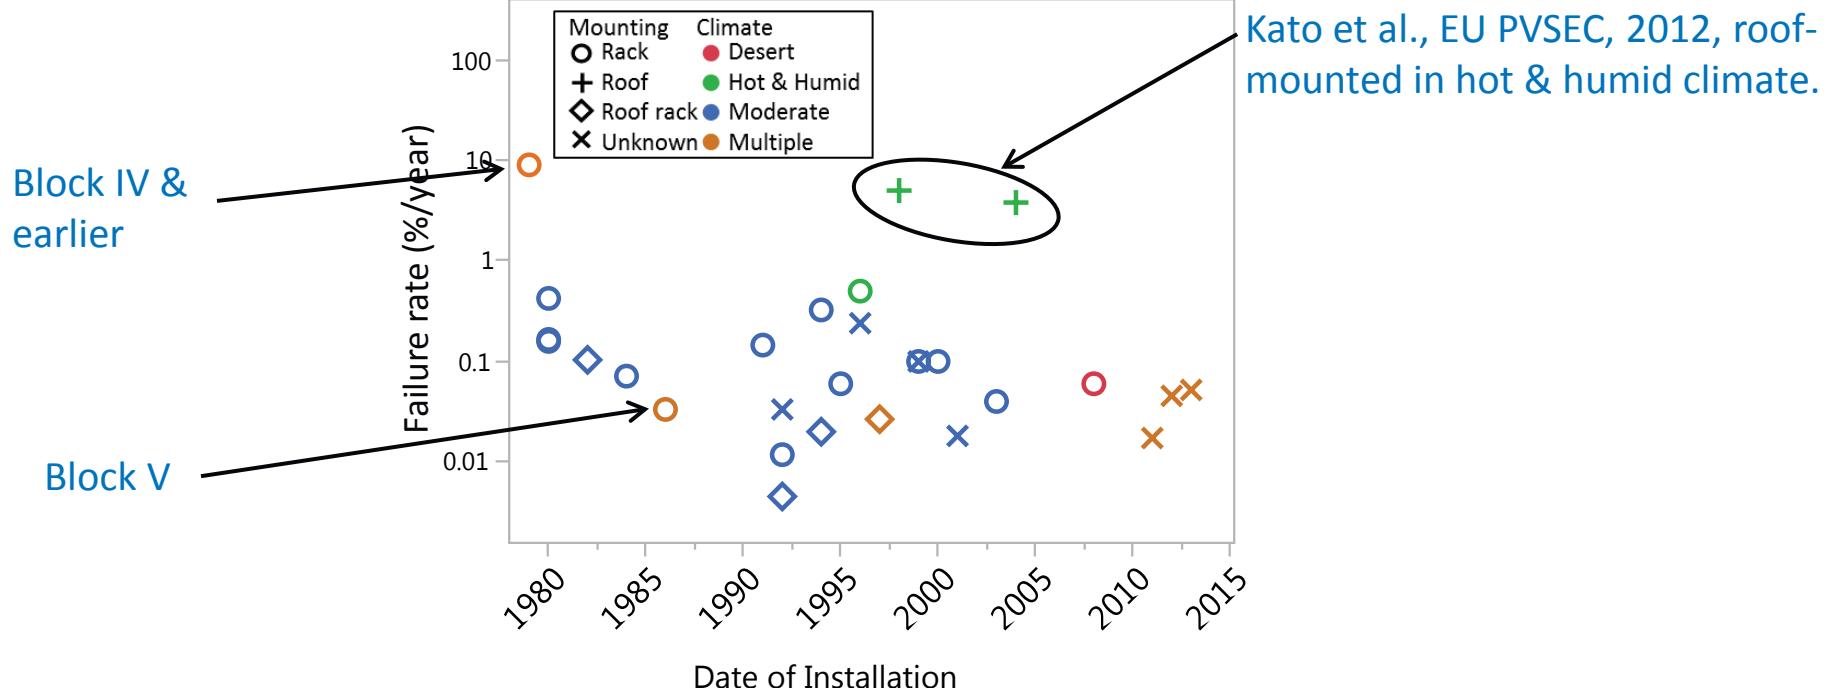
Define failure as modules that required replacement.

Expected failure rate 5 out of 10,000 modules annually

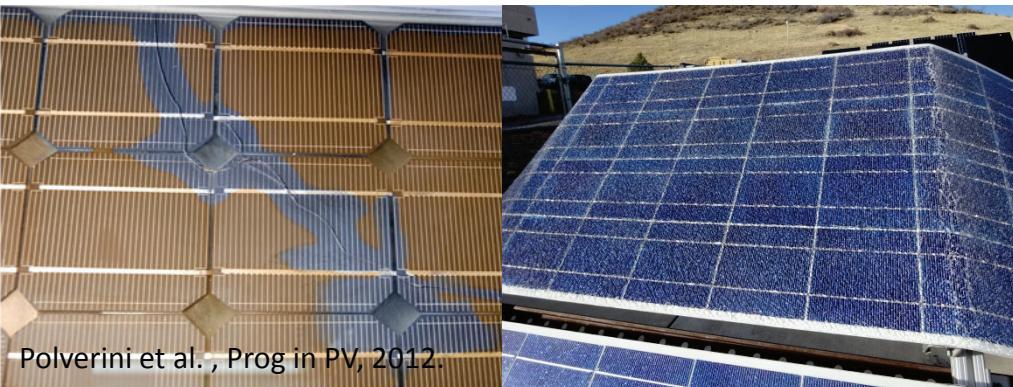
Example: front glass

Visual inspection could help discriminate between these cases

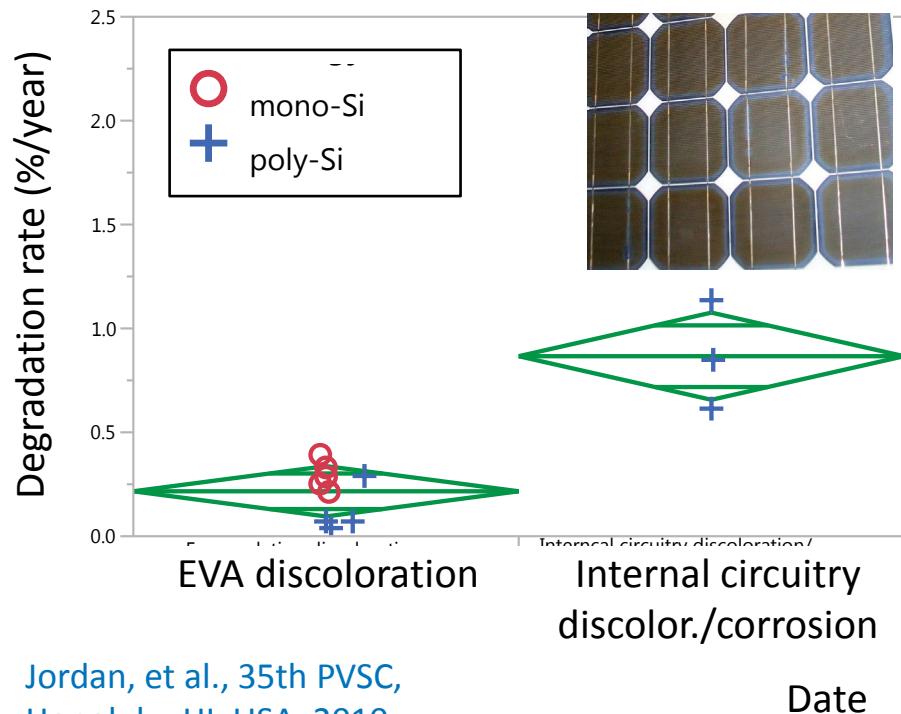
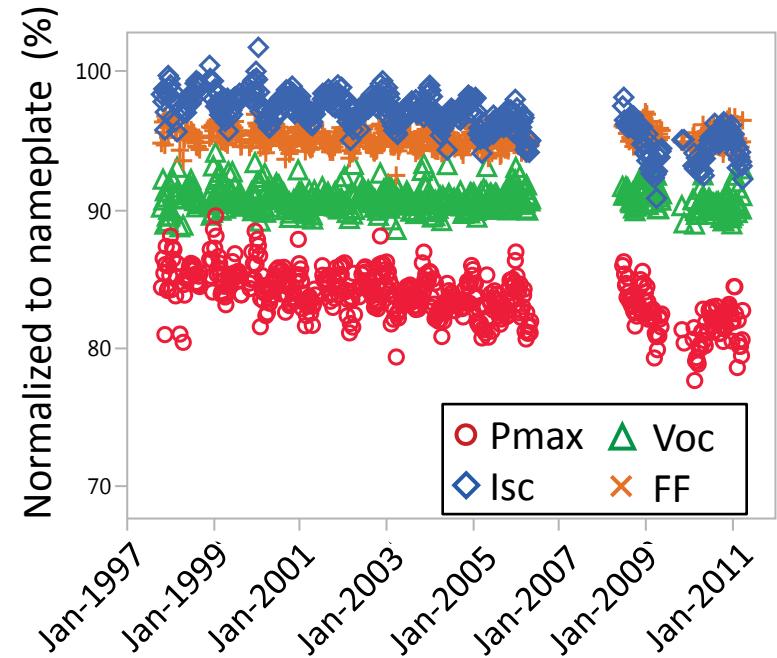
Encapsulation discoloration associated with small power loss

Encapsulant discoloration associated with lower power loss in direct comparison.

Encapsulant discoloration shows linear decline below 0.5 %/year, dominated by Isc losses.

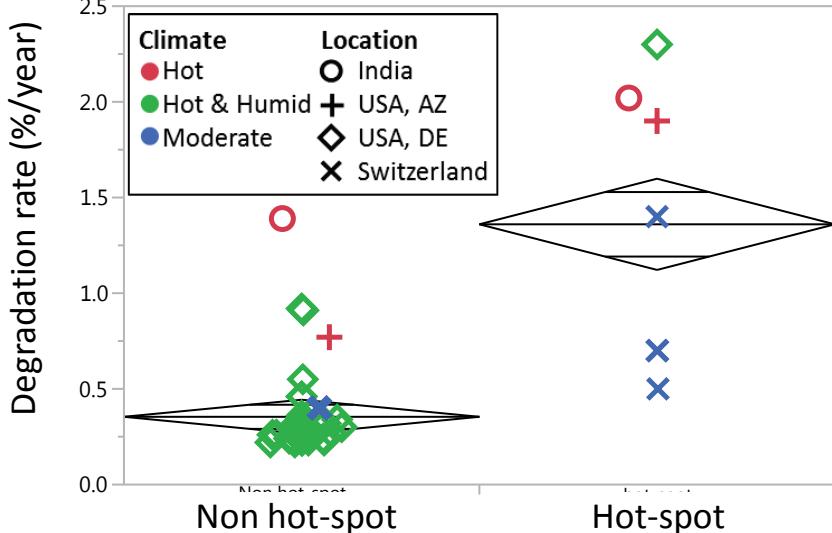
Hot-spots lead to larger power loss & pose safety issue

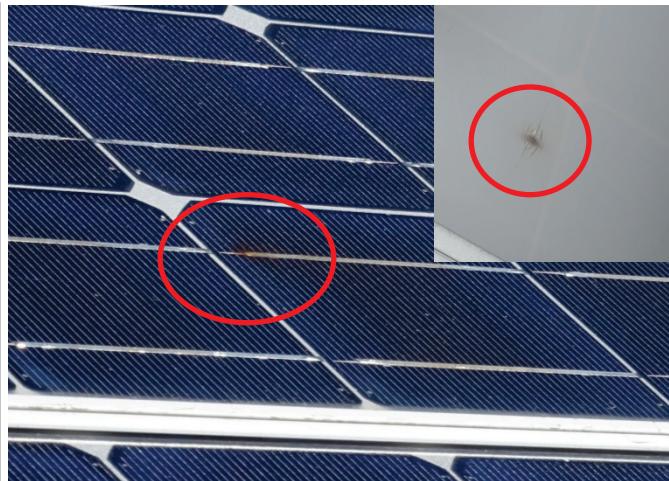
Internal circuitry (IC) failure due to solder bond

The first 20 years decline appears to be around 0.5 %/year.

More rapid decline associated with FF loss.

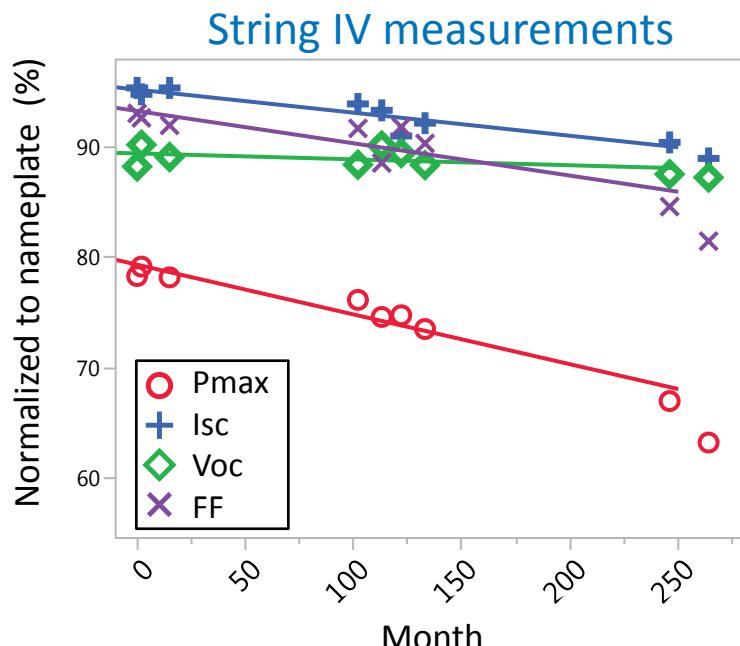
Hot spot because of cracked cell causing non-linearity

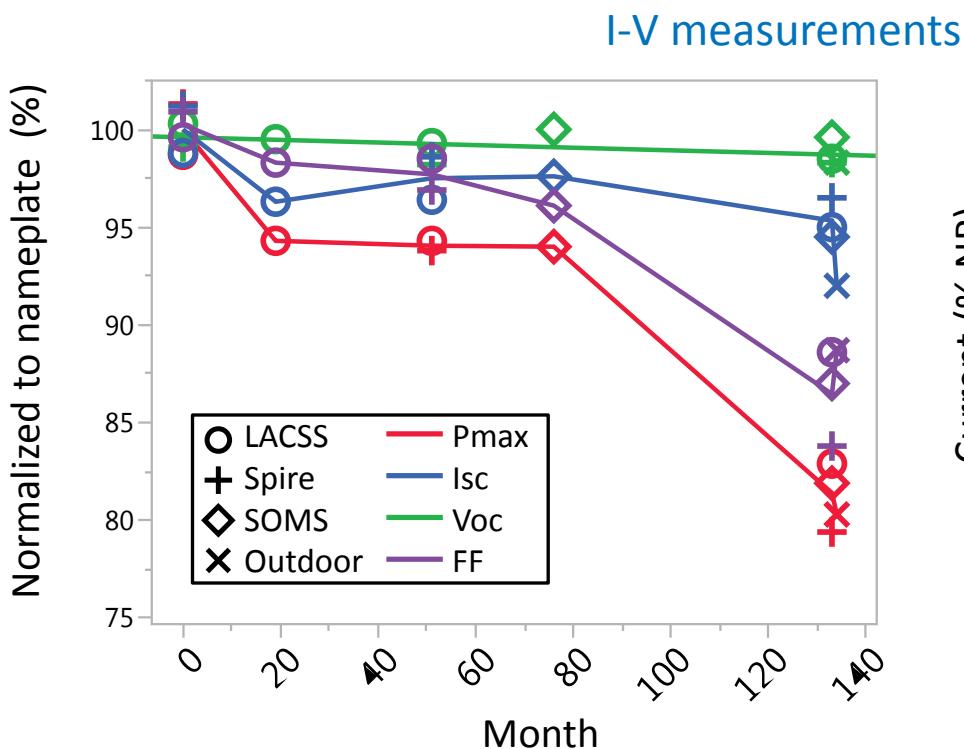
LACSS: large area solar simulator

Spire: indoor flash tester

SOMS: standard outdoor measurement system

Outdoor: Daystar field measurements

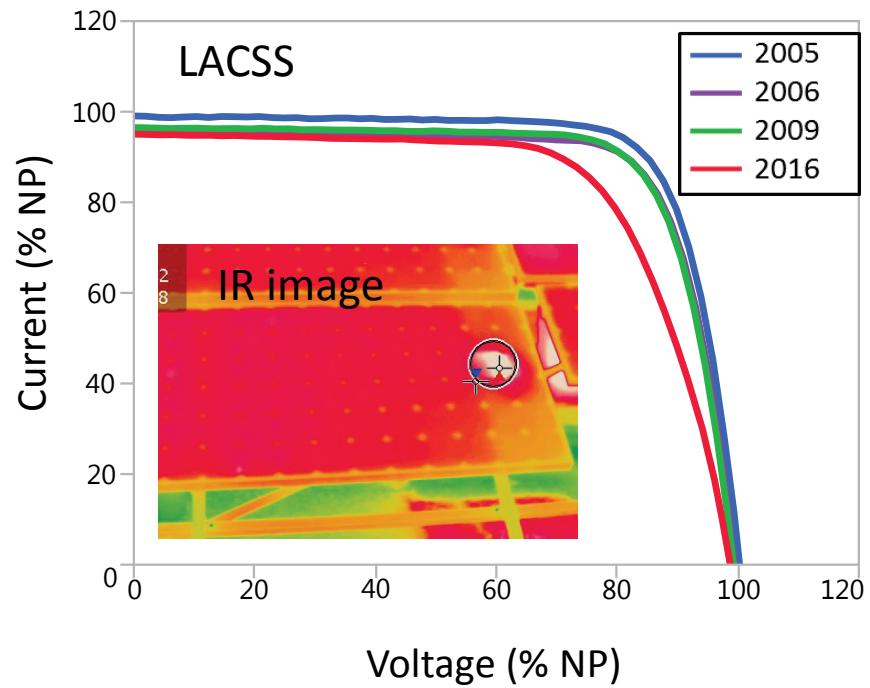
- ❖ Module was stable for several years
- ❖ Now we see more precipitous decline associated with FF losses, R_s increase

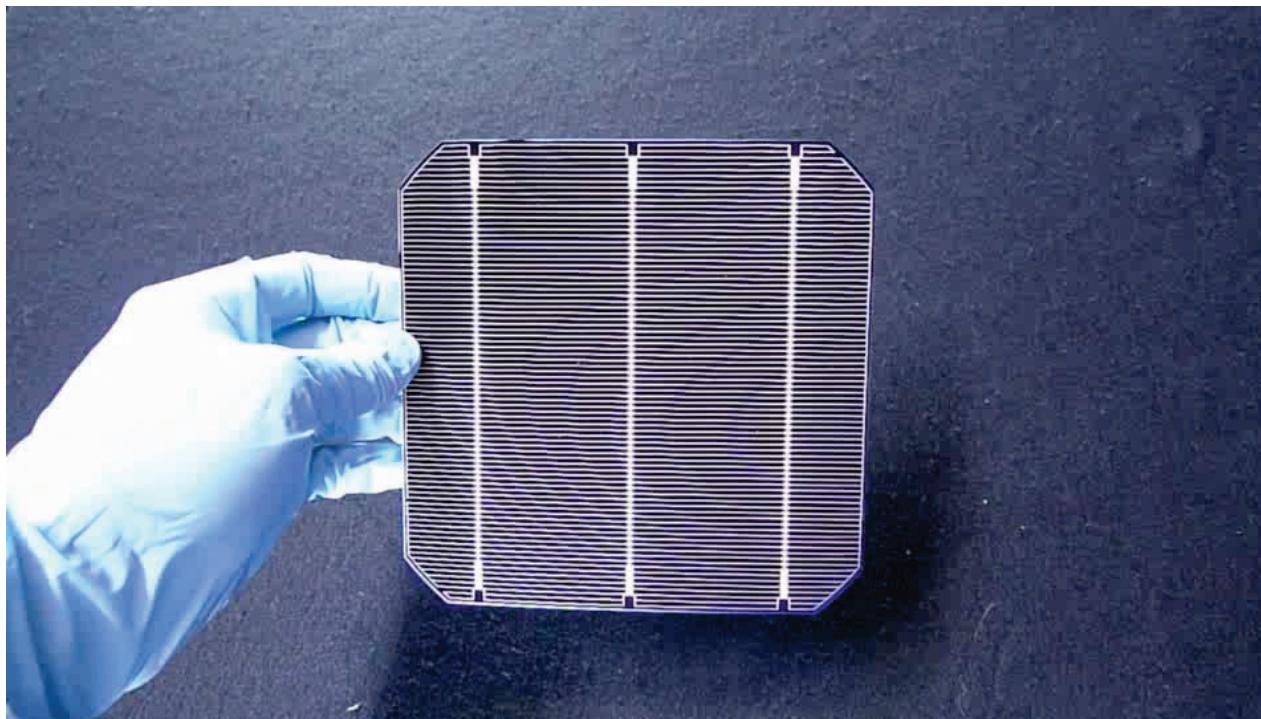
Cracked cells can easily be induced

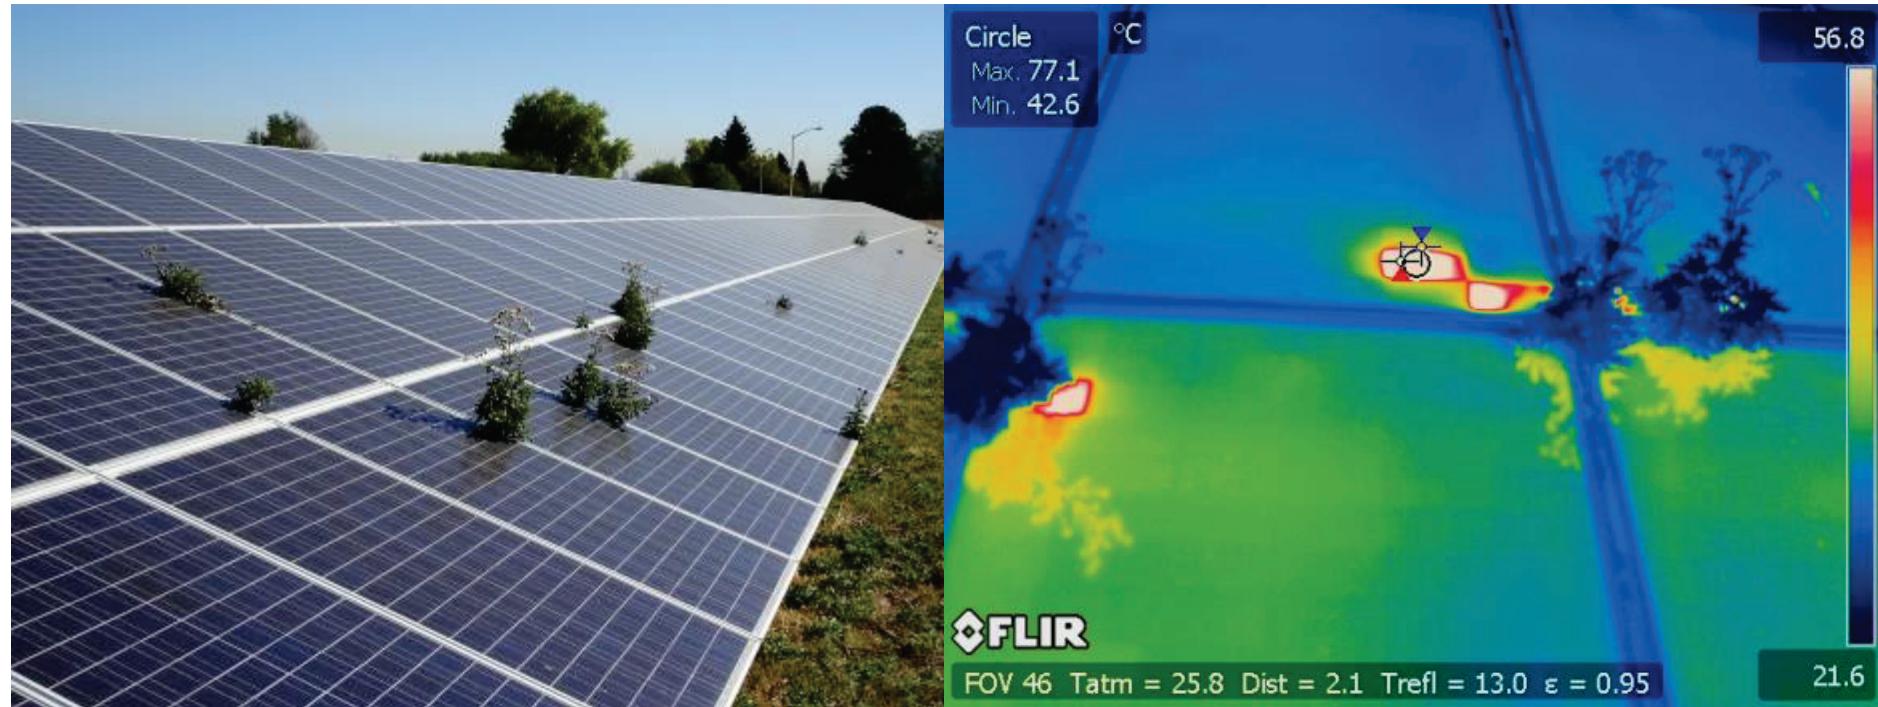
Other reasons for hot spots

Constant shading stresses bypass diodes and may eventually lead to diode failure

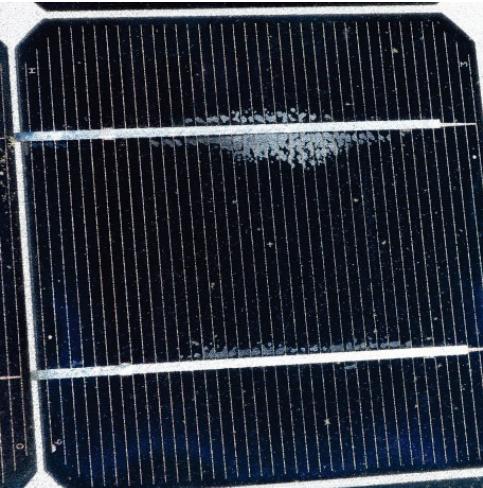
Encapsulant/Si

Initial stages

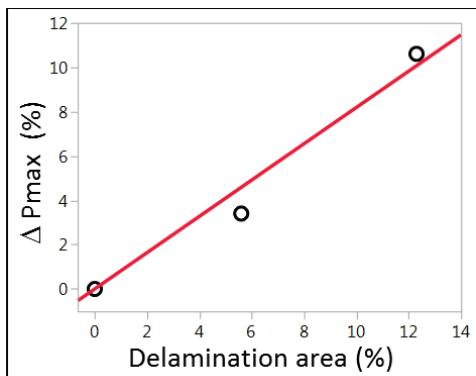
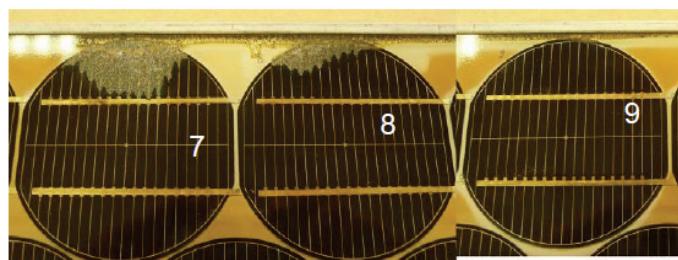
Before moisture ingress & corrosion delamination appears to scale with affected area, dominated by Isc losses

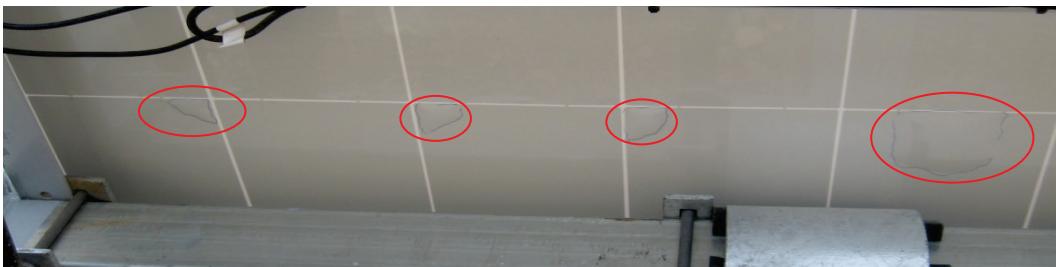
Minor issues

Backsheet issues can have different impact

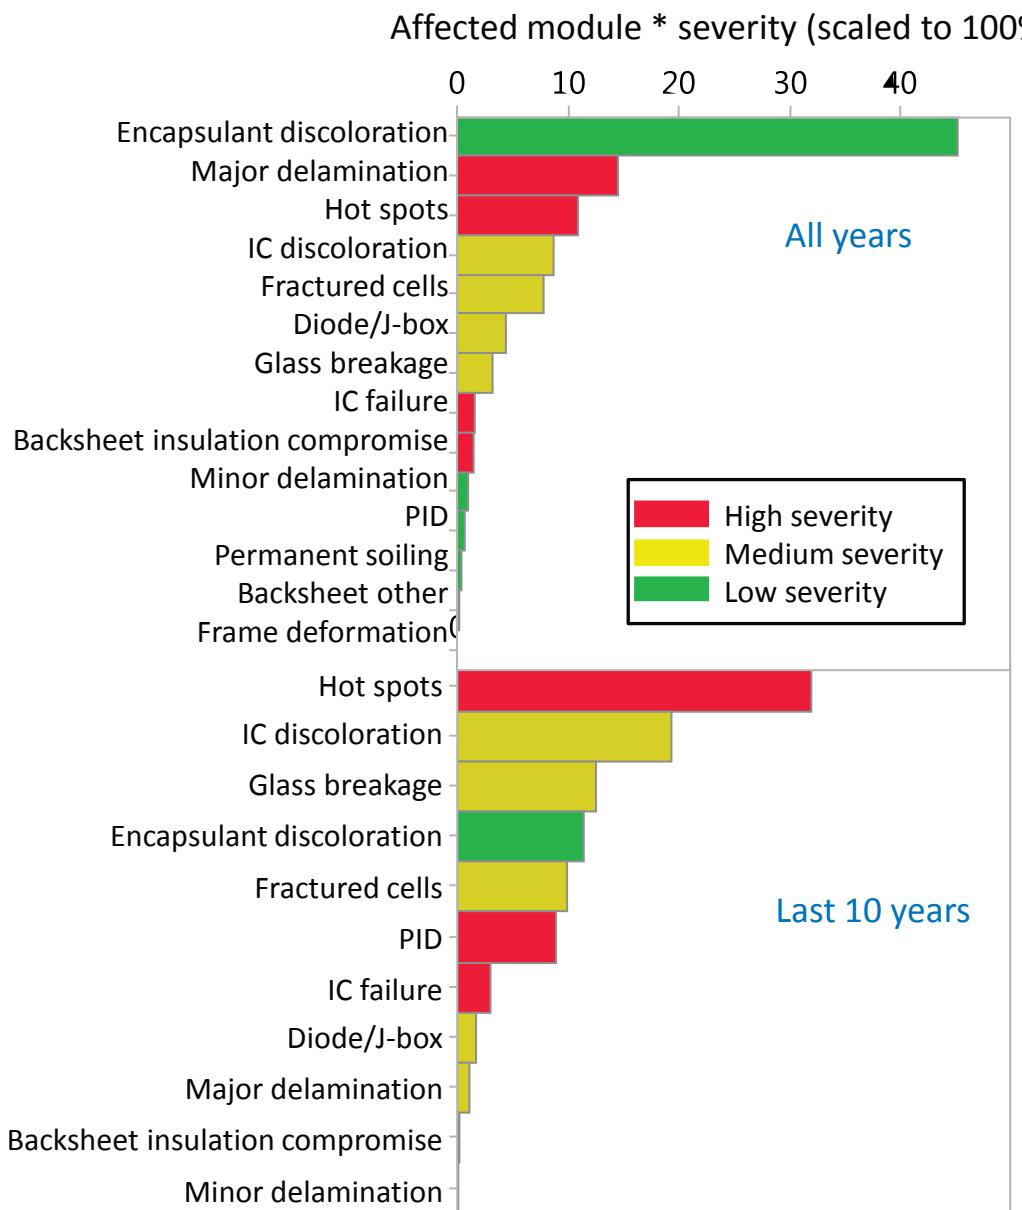
Hot-spots most common degradation mode in recent years

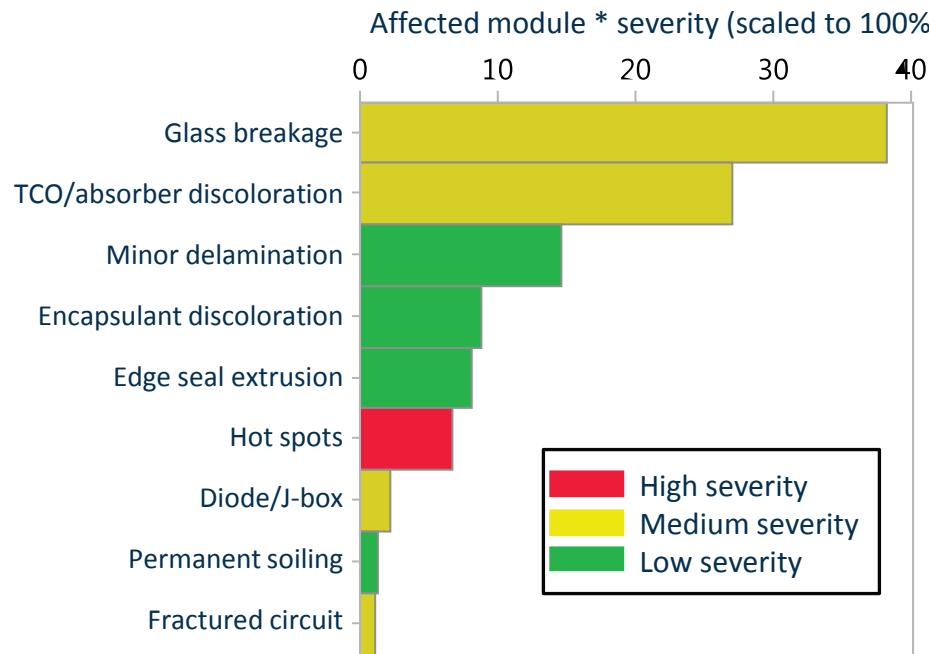
Thin-films: glass breakage most important

Don't have a lot of data on thin-film degradation modes

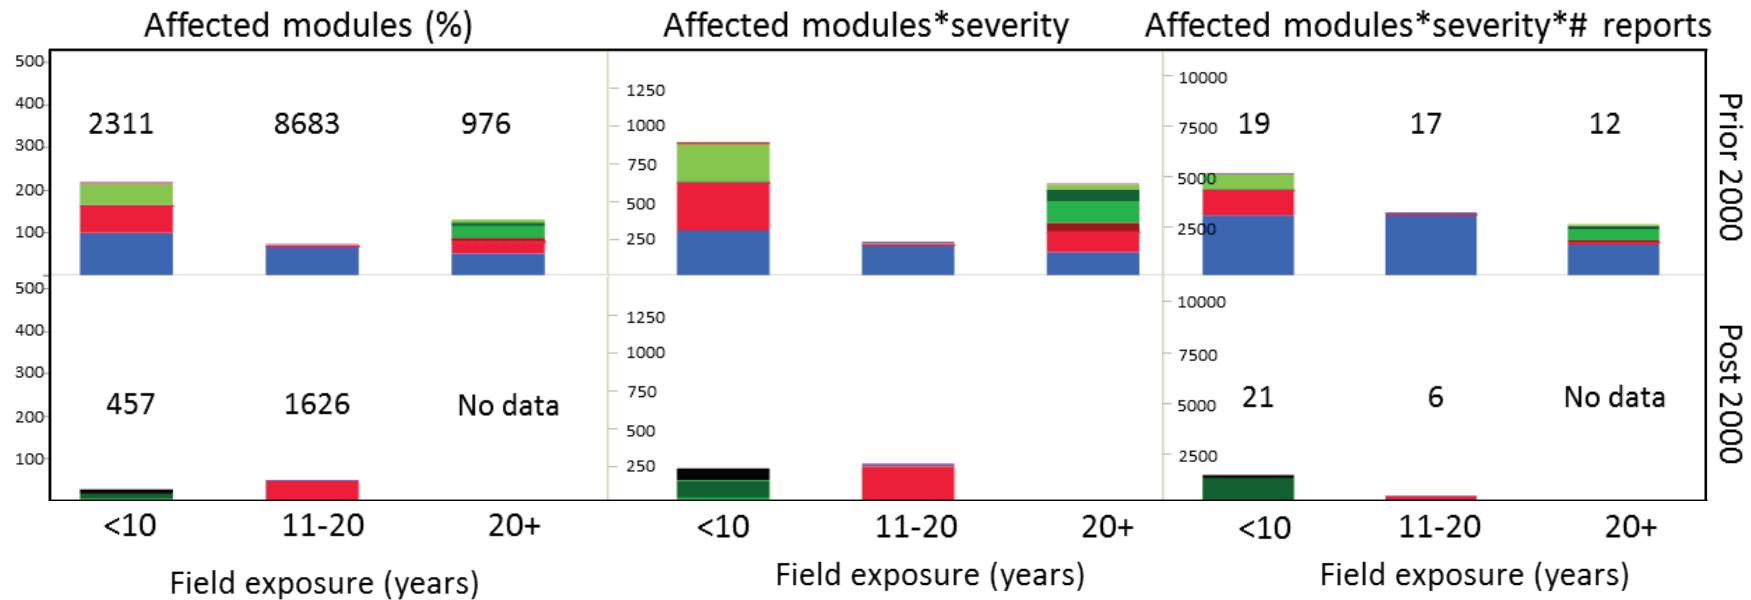
Moderate Climate

Percent of affected modules has gone down in newer installations

- ❖ Older installations, less than 10 field exposure dominated by pre-Block V modules
- ❖ Older installations: encapsulant discoloration dominant but absent in newer installations
- ❖ Percent of affected modules has gone down and changed.
- ❖ Hot spots & PID, and with more field exposure major delamination

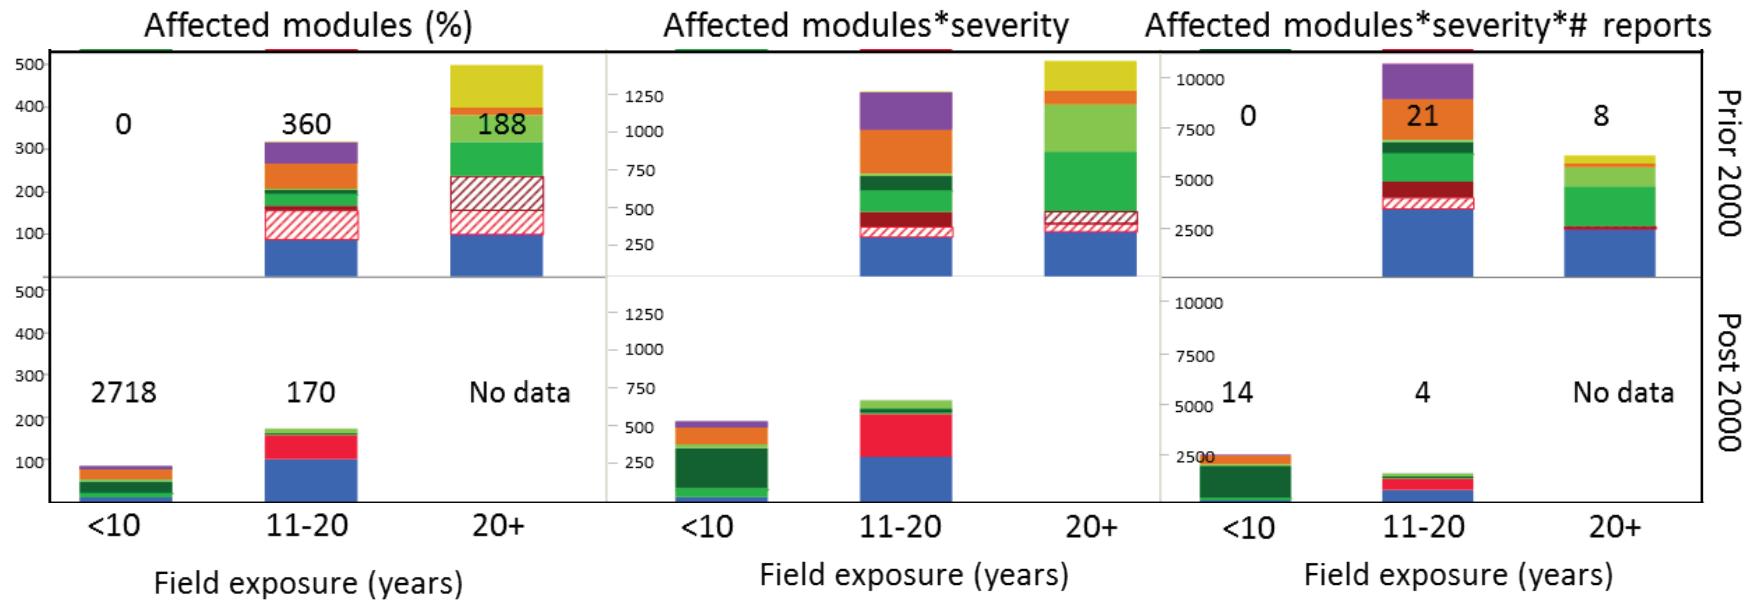
Hot & humid see higher fraction of modules affected

- ❖ Hot & humid climate more mix of degradation modes.
- ❖ Newer installations: hot spots, J-box issues
- ❖ For longer exposure major delamination appears
- ❖ Encapsulant discoloration still showing up in newer installations

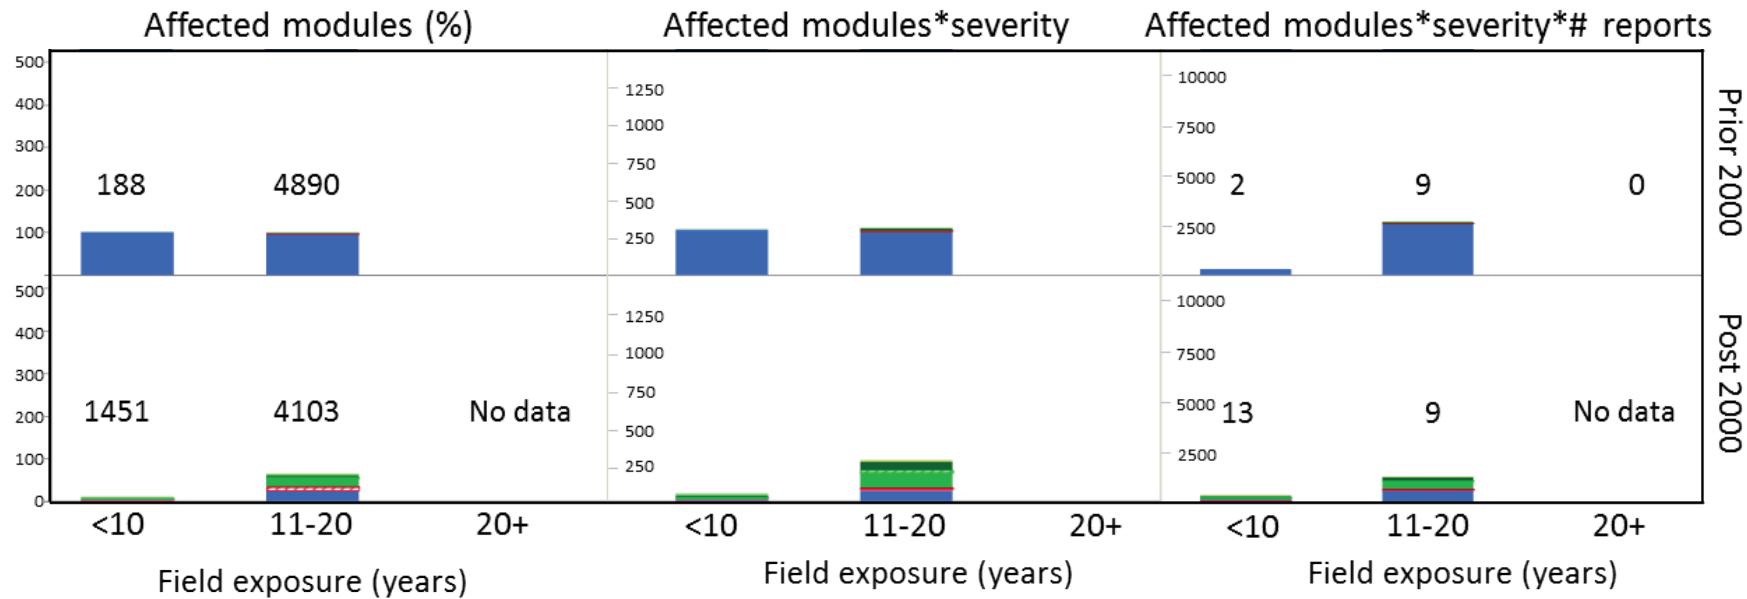
Desert climate

Desert, new installations: hot spots & internal circuitry discoloration

- ❖ Older installations: encapsulant discoloration
- ❖ Newer installations: hot spots & internal circuitry discoloration
- ❖ Encapsulant discoloration still showing up in newer installations

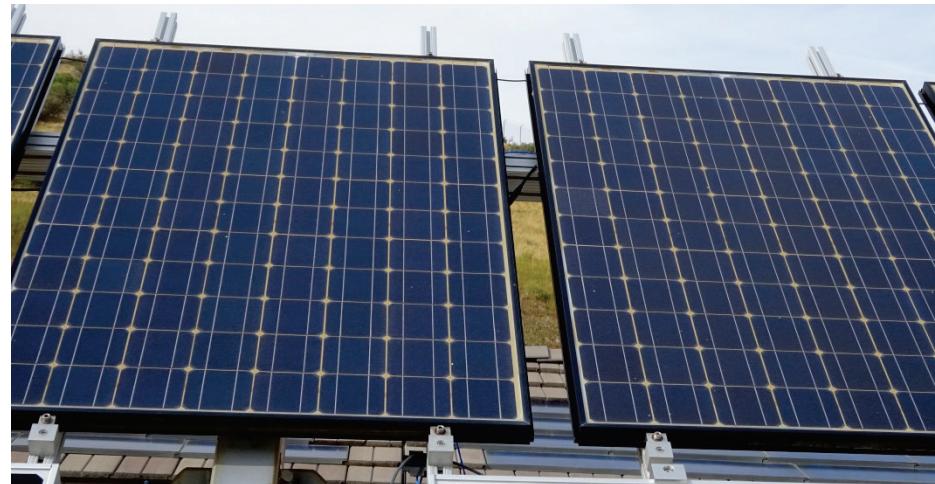
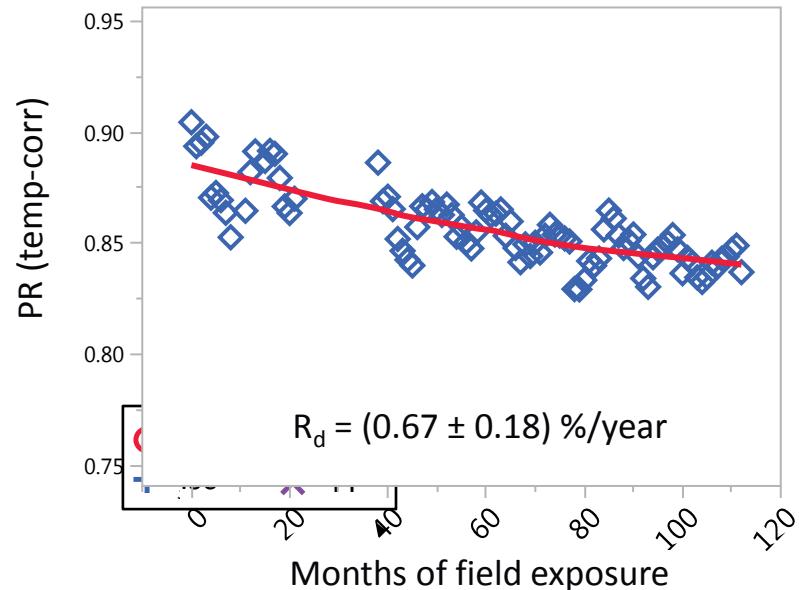
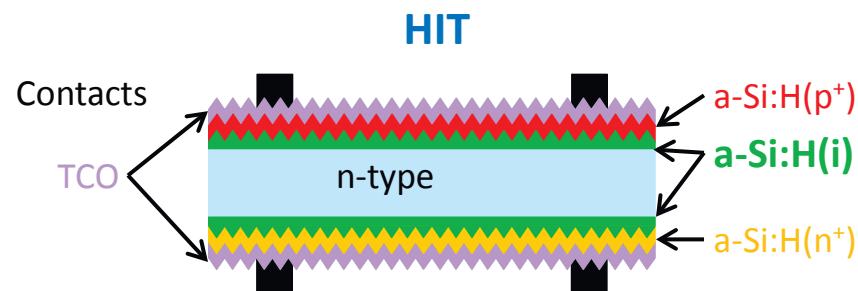
HIT (heterojunction with intrinsic thin layer)

- System size: 1kW, 5 modules
- Installed Sep. 2007
- Kept control module indoors
- **Degradation is within warranty**

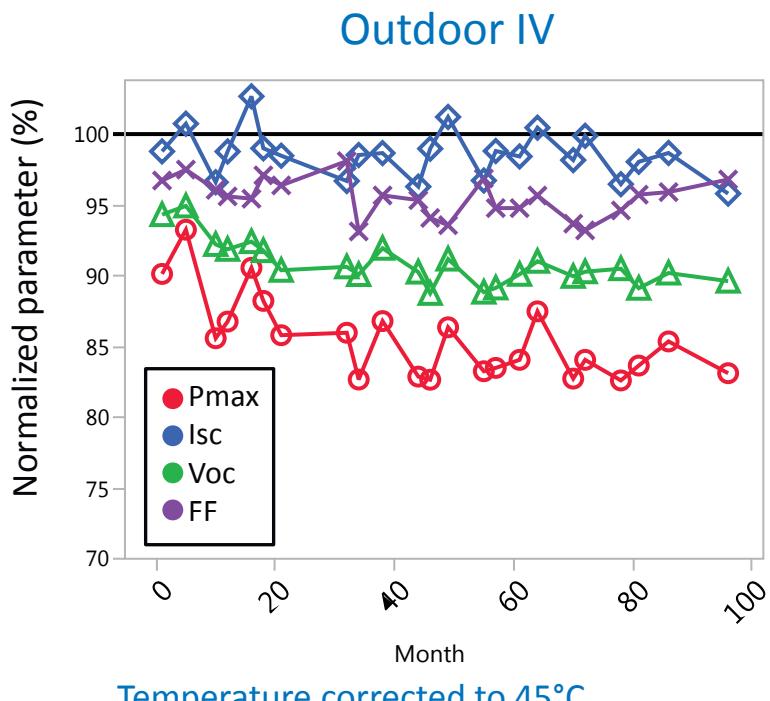
Nonlinear decline in Voc

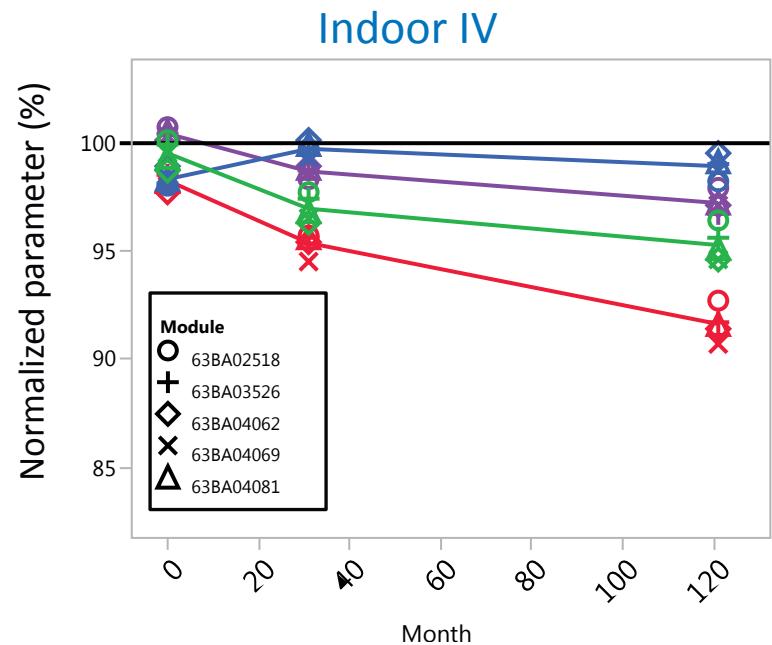
Temperature corrected to 45°C

Isc: within measurement uncertainty

FF: small decrease

Voc: most of the decline in first 2 years

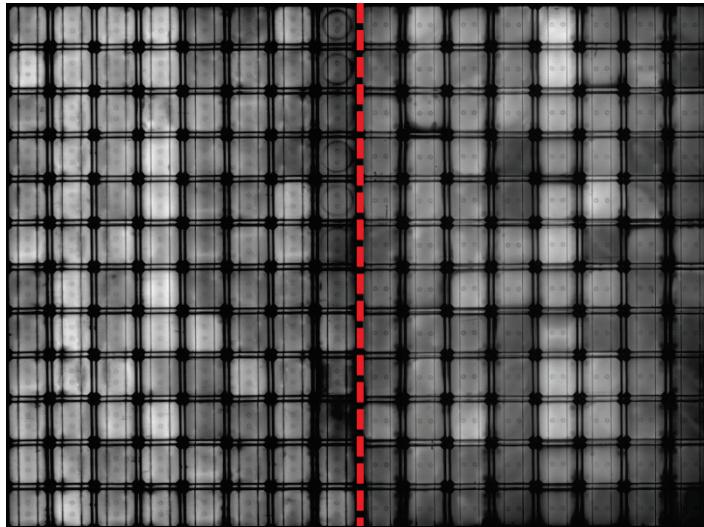
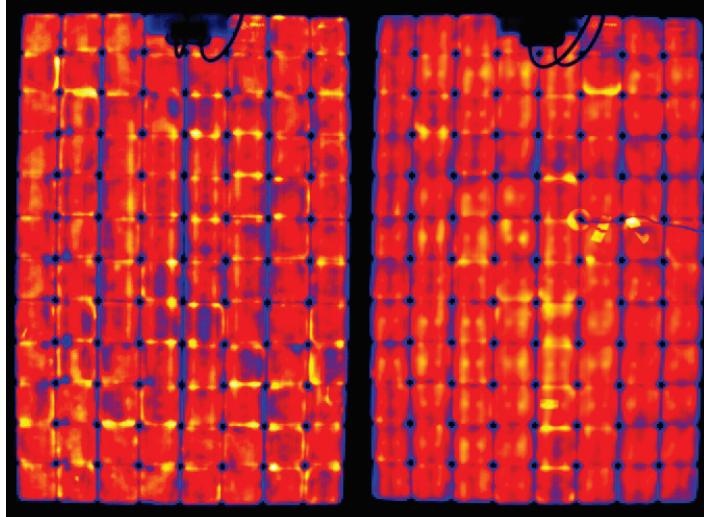
Electroluminescence

Dark Lock-in Thermography

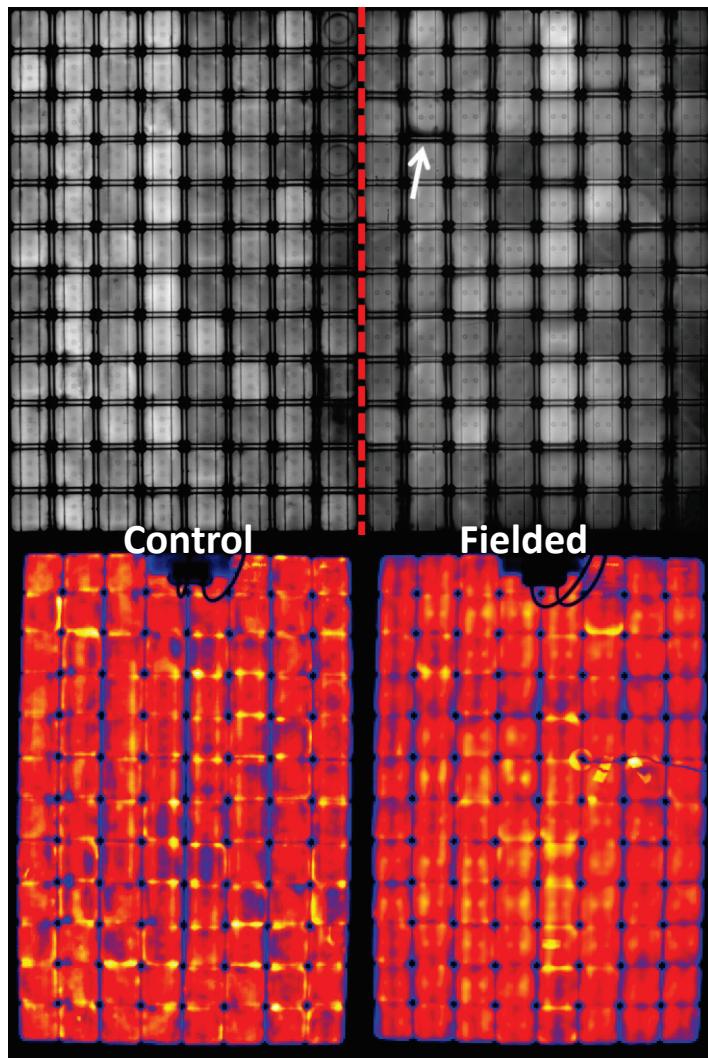
Electroluminescence

Dark Lock-in Thermography

Uniform across module, R_s increase

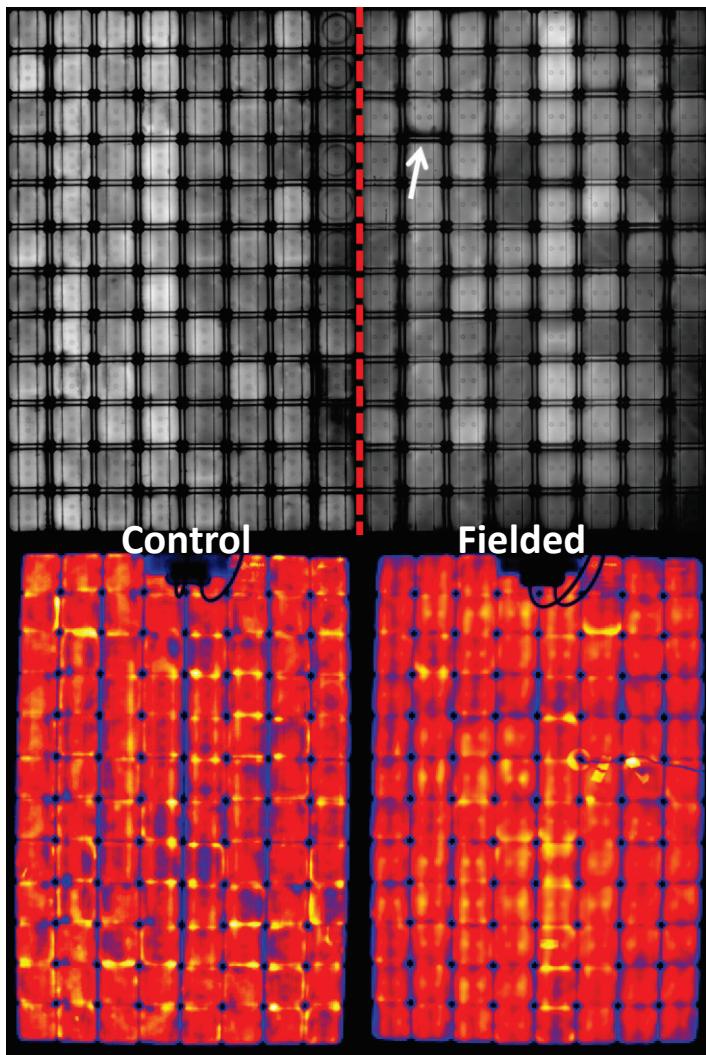
Electroluminescence

Dark Lock-in Thermography

Some cells show slight edge-shunting, but..
it is also present in the control module!

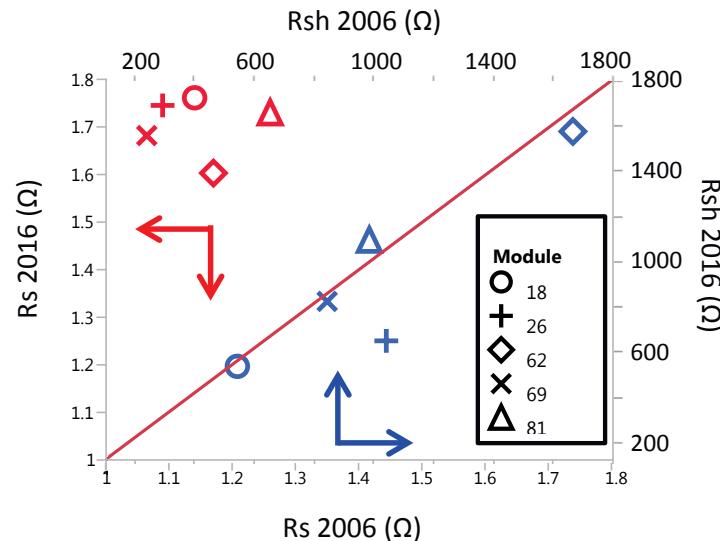
Dark IV taken in 2006 & 2016

Some series resistance increase
No shunt resistance decrease

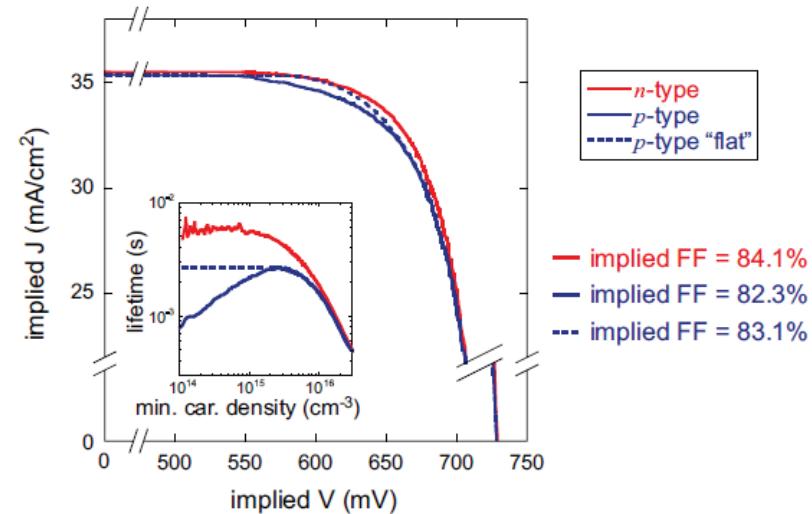
Same HIT structure on n- & p-type

p-type lower FF \rightarrow lower quality passivation layer
Appears as a slightly “higher series resistance”
Passivation layer is degrading

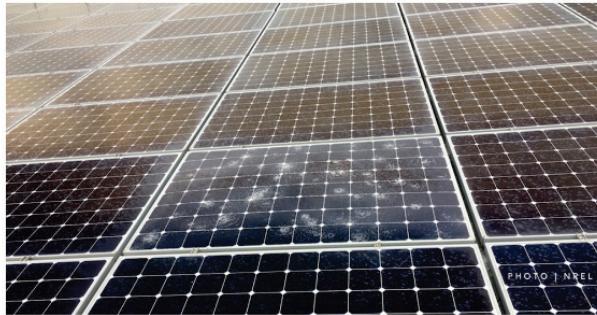
Just one PV panel out of more than 3,000 was damaged at NREL following the hailstorm. Photo | NREL

10 modules out of 3790, 8 year field exposure
→ failure rate $\lambda = 0.03\%/\text{year}$
